# **Update on the Halden work on coatings**

## Performance of CrN coated claddings

### PIE results of the first in-core test on coated fuel rods

NEA- 5th EGATFL meeting, 12-14 April 2016 ,  
Boulogne-Billancourt, Paris

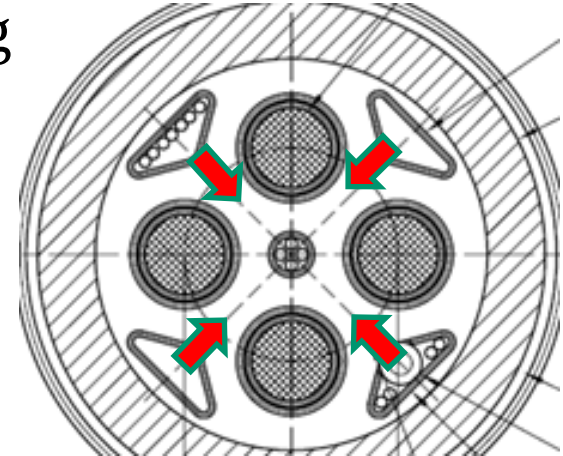
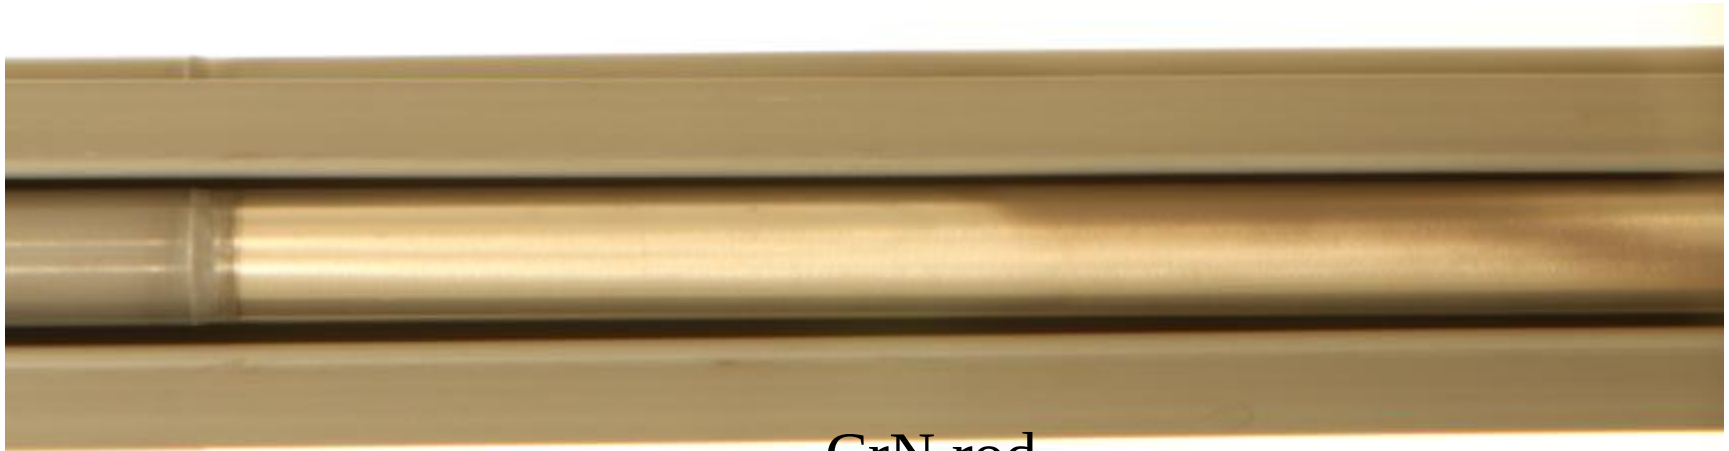
CrN rod

## Bending of downcomer tubes towards fuel rods

increased temperature of cladding

«Accident conditions» over 144 days!

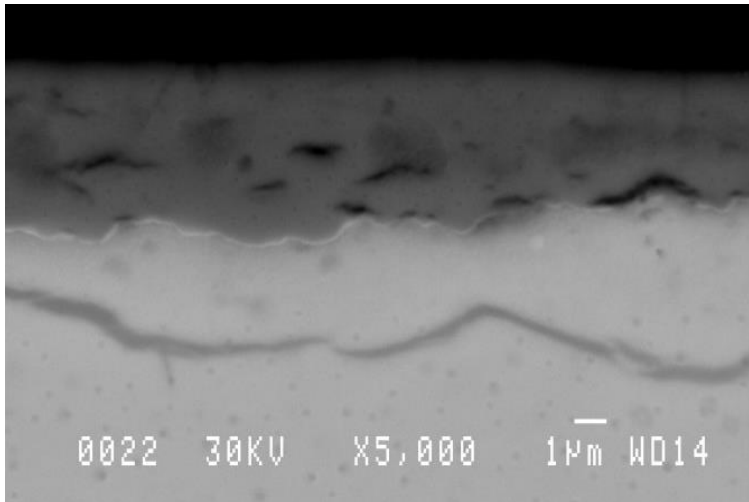
- The oxide has high porosity/circumferential cracks that locally create oxide layers
- Porosity/cracks were observed both close to the cladding and throughout the oxide thickness
- Oxide spallation/delamination has occurred at several locations

Porosity/cracks in the oxide and delamination/spallation are more severe than expected for low burnup PWR conditions.

These features could be an effect of higher temperature of the cladding.

Oxide thickness:  
About 5.5  $\mu\text{m}$

SEM backscattered mode – IFA-774, Zry-4, 60mm –  
High porosity/circumferential cracks divide the oxide into several layers.

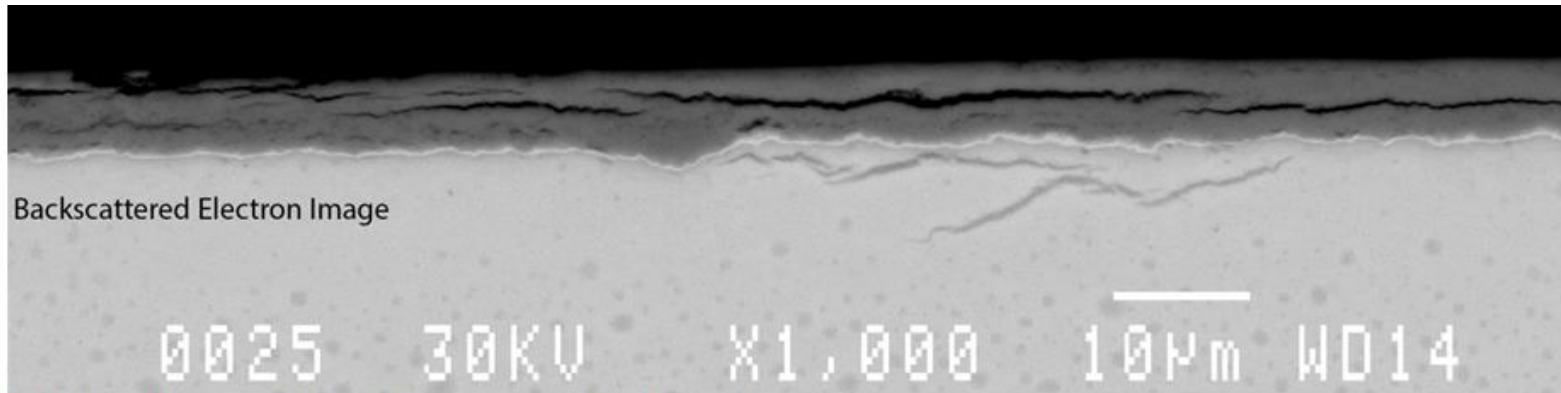
Fig. 2 SEM SEI + BEI – IFA-774, Zry-4, 60mm – Zirconia delamination

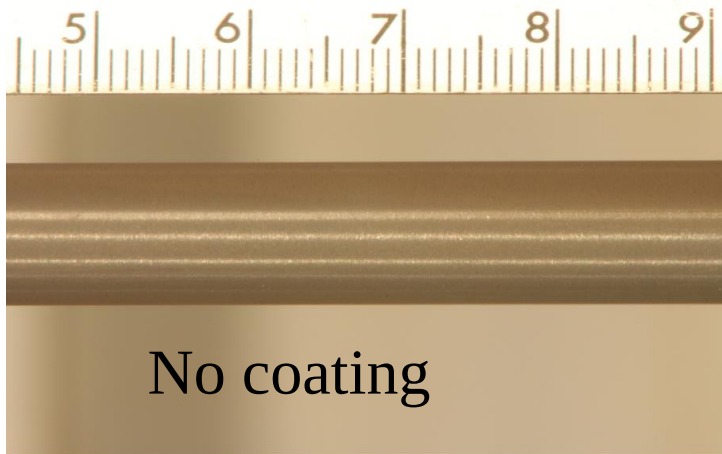
From visual inspection, the CrN seemed to survive

**Note:** Due to bending of downcomer tubes, the temperature of the rods increased substantially

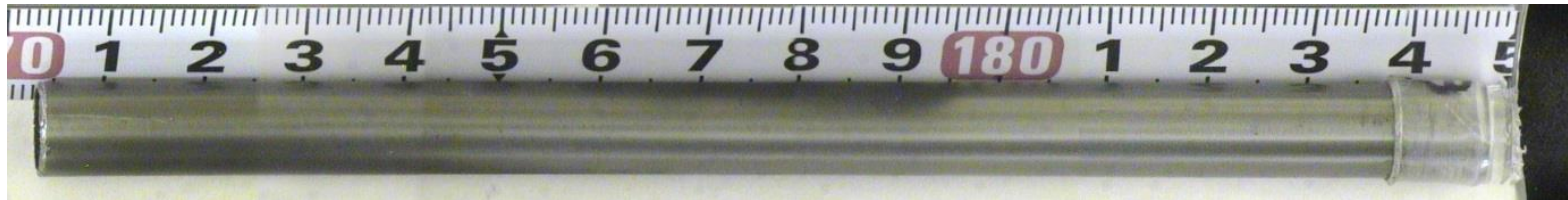
Visual inspection of CrN coated Zr-4 tube from IFA-774 – 0 degree

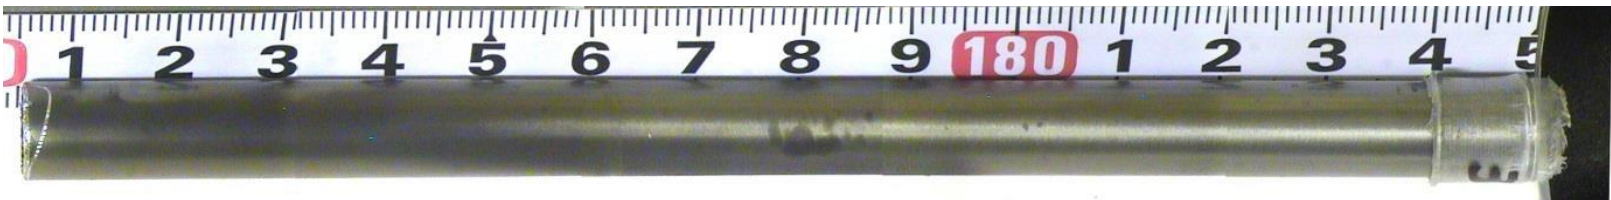
Visual inspection of CrN coated Zr-4 tube from IFA-774 – 180 degree

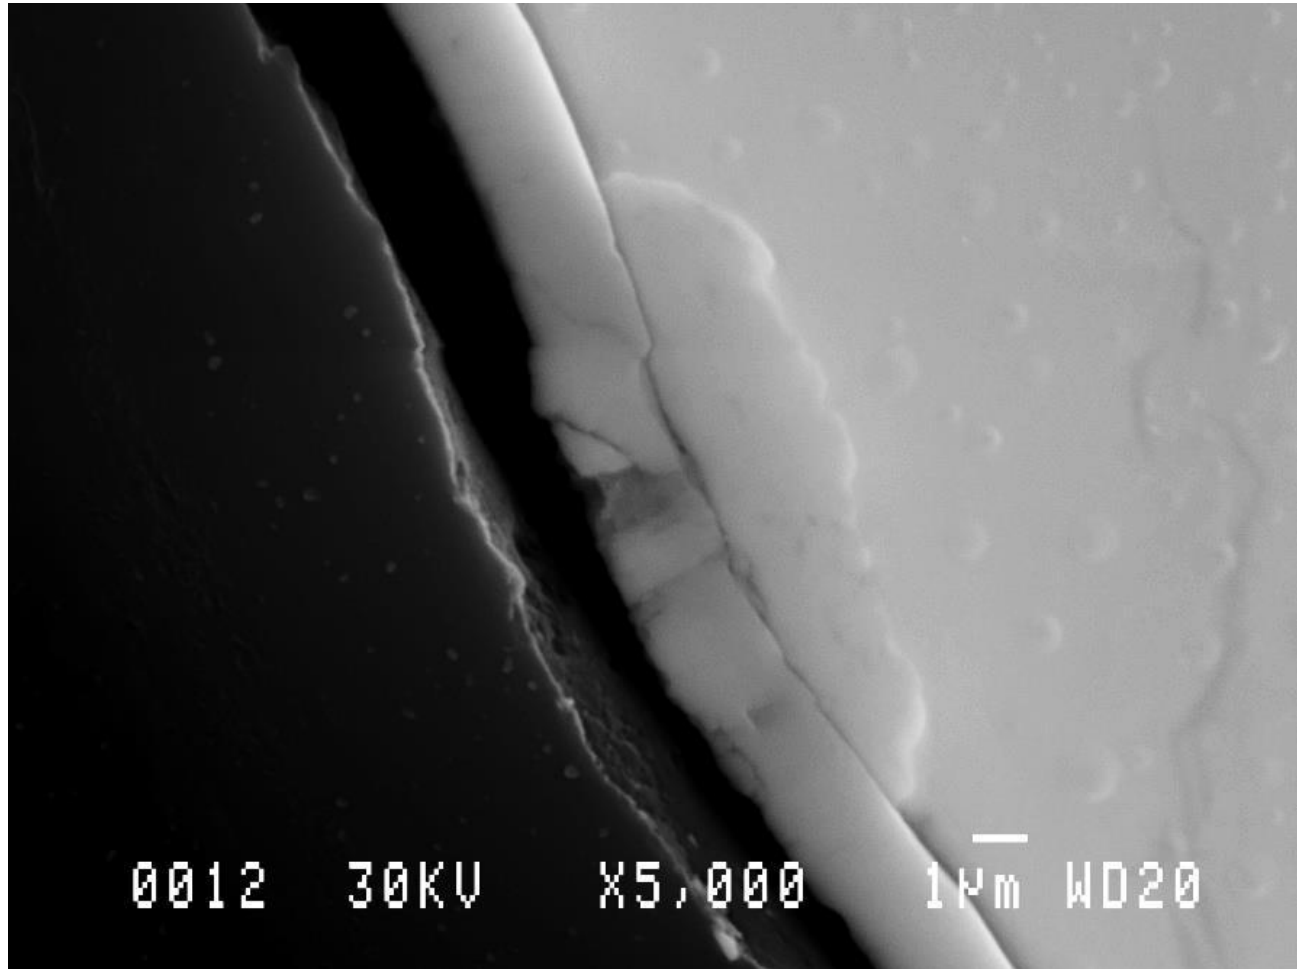
CrN coated Zr-4 tube from IFA-774 - After irradiation at 30mm Oxide under coating

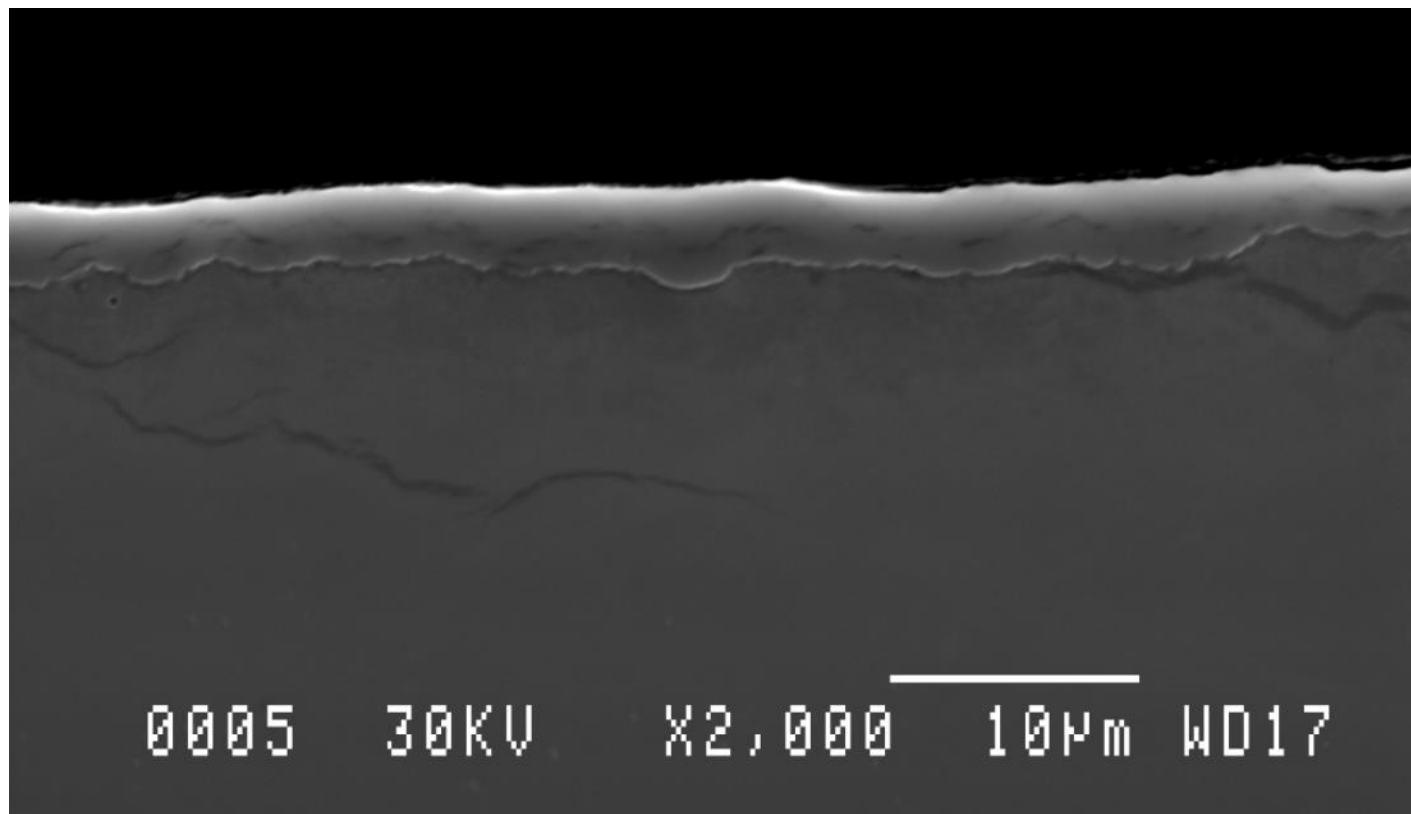
## SEM analysis of TiAlN coated rod

Coating disappeared.

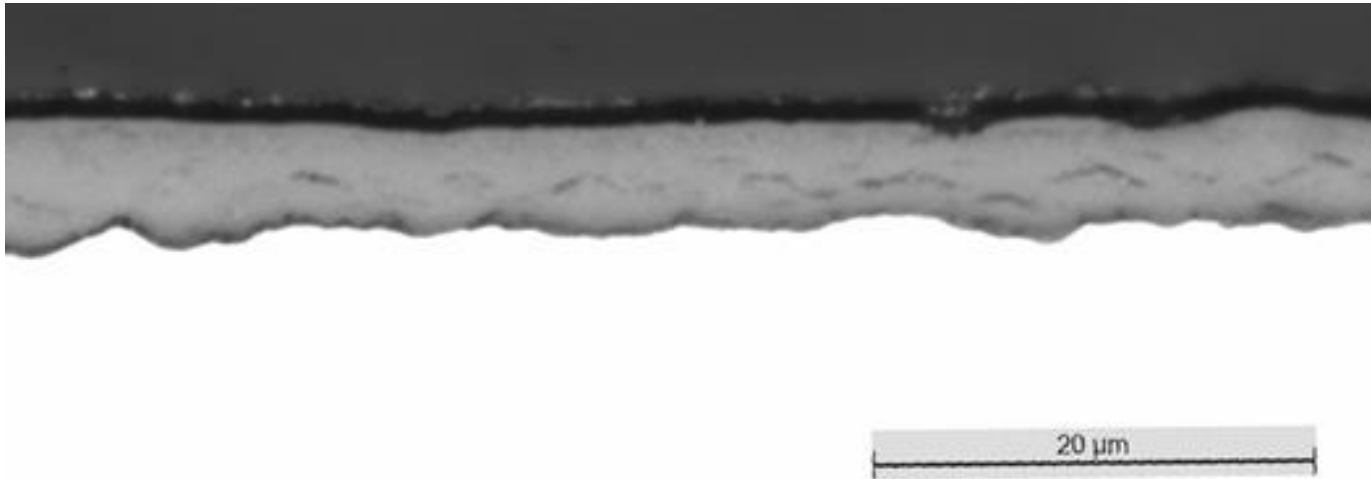
## Optical investigation AlCrN coated rod

Coating disappeared.

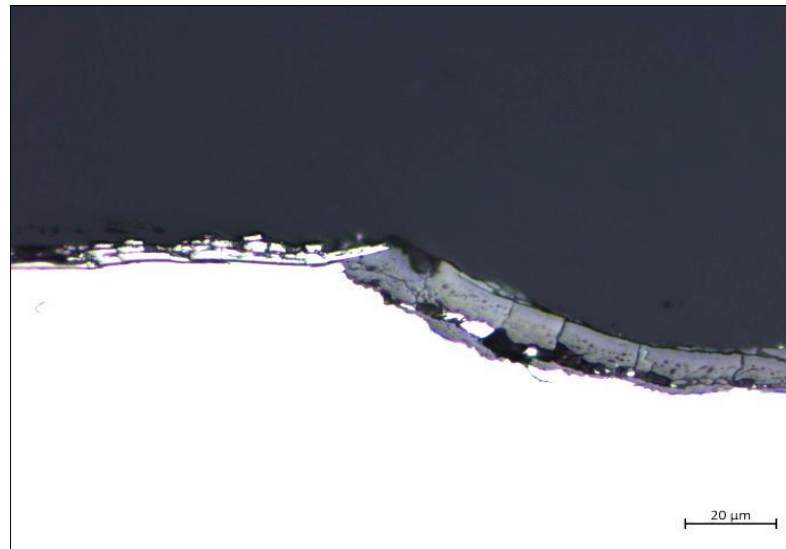
- 750 °C, 60 minutes : CrN coating survives
- 1000 °C, 15 minutes: CrN coating survives
- In the presence of cracks, oxide starts forming and can grow under the coating, pushing the coating outwards

Example:  
750°C, 60 minutes  
With machined scratch
