OECD Fire Project – Topical Report No. 1

Analysis of High Energy Arcing
Fault (HEAF) Fire Events

NEA/CSNI/R(2013)6

**OECD FIRE Project - TOPICAL REPORT No. 1
Analysis of High Energy Arcing Fault (HEAF) Fire Events**

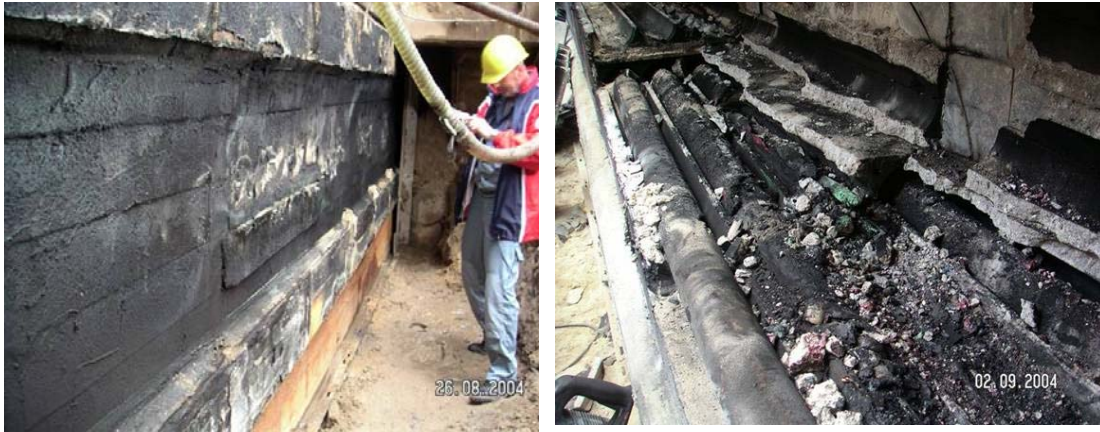
A high energy arcing fault event initiated by a spontaneous short circuit of some seconds duration occurred in a 10 kV cable at a BWR type plant built to earlier standards on August 23, 2004 resulting in an overcurrent of approx. 30 to 35 kA during full power operation. The affected cable was routed from the station service transformer together with other cables through an underground cable channel to the electrical building. Due to the conditions in the ground, cables were partly imbedded in concrete cable cylinder blocks.

Neighboring cables were not affected. Within the time period of the electric arc PVC insulated cable including the copper conductor evaporated completely on a length of approx. 1 m (see photo in Figure 0-1).

Figure 0-1: Photos of the cable damage; left: location of the damaged cable, right: damage by the cable fire/evaporation

Ageing of the cables due to lightning protection features installed as backfitting measure resulting in insufficient heat removal from the high voltage cables in the concrete cylinder blocks was found to be one of the root causes,

As a corrective action, all safety related 10 kV cables with PVC shielding have been replaced by new ones. In addition, periodic in-service inspections with respect to the leakage resistance of the cables are being performed. Another effect of the event was the smoke propagation to an adjacent cable channel via a drainage sump. As a preventive measure, after the event each cable channel has been supplied by its own drainage system. Moreover, all the channels are now separated by fire barriers with a resistance rating of 90 min.

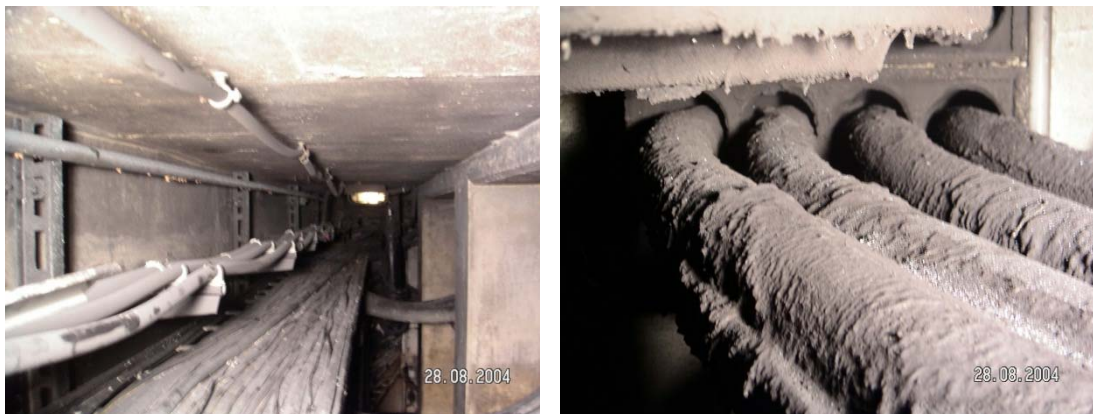
The high energy arcing did not result in any fire propagation; combustion was limited to the location where the short circuit occurred. The fire self-extinguished immediately after the electric current had been switched off. The fire duration was only a few seconds, however, the smoke release was high. It has to be mentioned in this context that all cables inside the cable channel had been protected by intumescent coatings ensuring the prevention of fire spreading on the cables (see Figure 0-2).

Figure 0-2: Cables with protection by intumescent coating; left: photo of the cable channel, right: photo of the coating

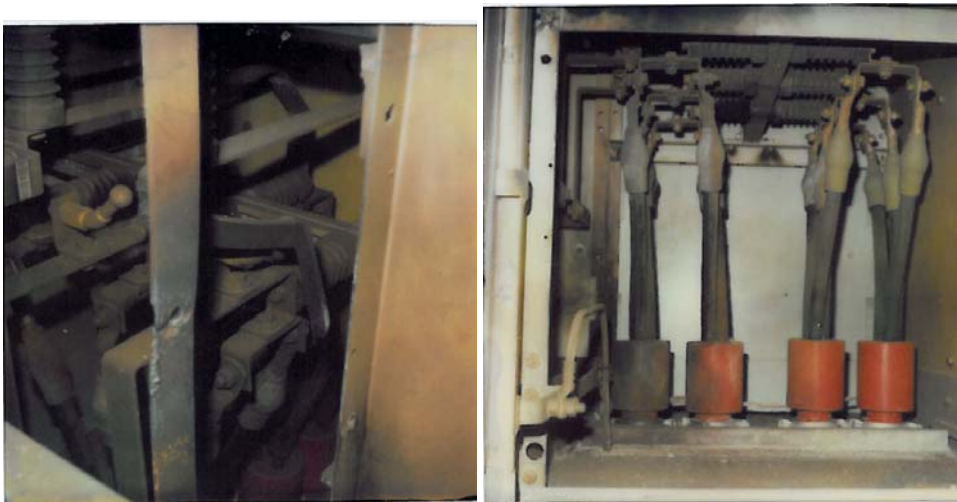
Another HEAF event with explosion, consequential fire and deterioration of fire barrier elements was observed at a PWR plant during full power operation on September 9, 1987. The arcing occurred in an electrical cabinet of an emergency diesel generator Performing a load test during the in-service inspection (4-week intervals) of the emergency diesel generator an electric arcing fault initiated a short to ground in the electric cabinet of the of the emergency diesel generator exciter system (cf. Figure 0-3). The root cause of the arc with short to ground is assumed to be a loose screw. The ionization of air by the arc led to a short circuit within approx. 4 s resulting in the isolation of the emergency busbar after another 0.1 s.

Figure 0-3: Photographs: a) view into the exciter cabinet, in the foreground location where the screw loosened and b) view into the cabinet

A combination of technical and human causes was found to be the root cause. To prevent recurrence, inspections regarding potentially loose screws were carried out for the other redundant trains.

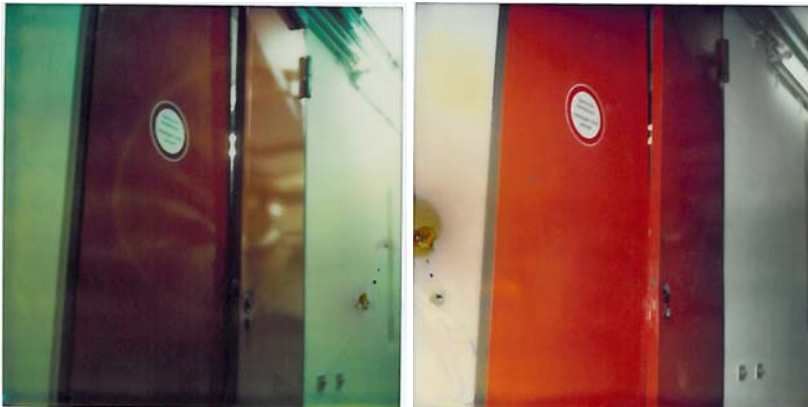
The smoldering fire resulting from the explosion initiated by the electric arc is assumed to be caused by the short circuit of the emergency diesel generator. The overcurrent observed could unfortunately not be measured. Due to the HEAF a sudden pressure increase occurred in the room (dimensions about: 3.6 m x 5.5 m x 5 m) damaging the two-wing fire door (cf. Figure 0-4).

Figure 0-4: Photographs of the damaged fire door from outside the room

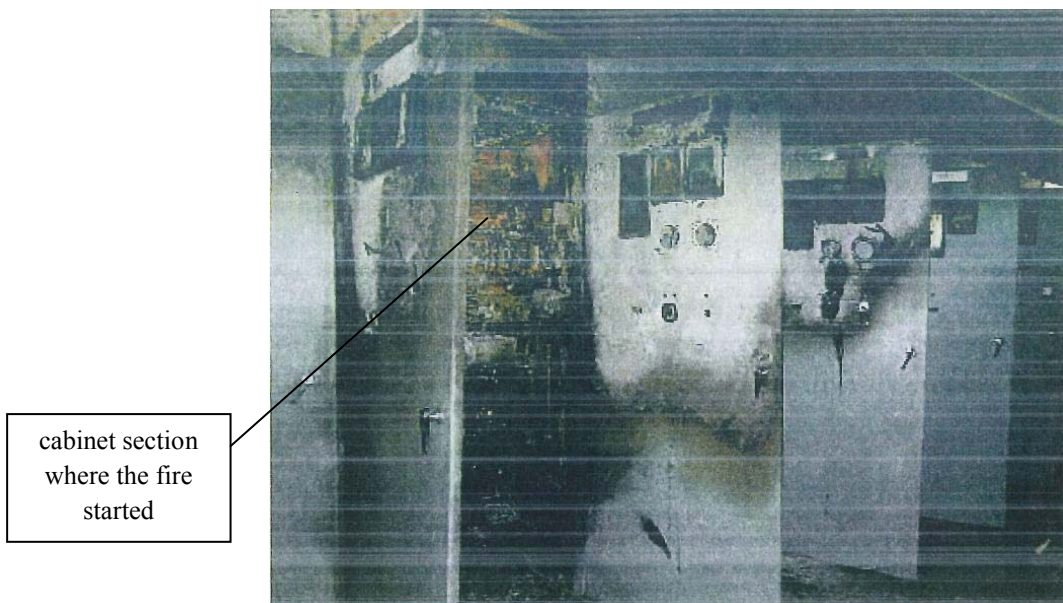
- Jackets and insulators of the cables above M/C 6-1A seem to be affected by the fire.
- Other components and/or cables except those just above M/C 6-1A were not affected by the fire.

- There were no missiles.
- The door of the cabinet sector, where the fire started, opened when the on-site fire brigade accessed the room. It is unknown whether the door opening is due to the earthquake or the pressurization of the cabinet.

Figure 0-7: Electric cabinet with the sector where the fire started and others impaired

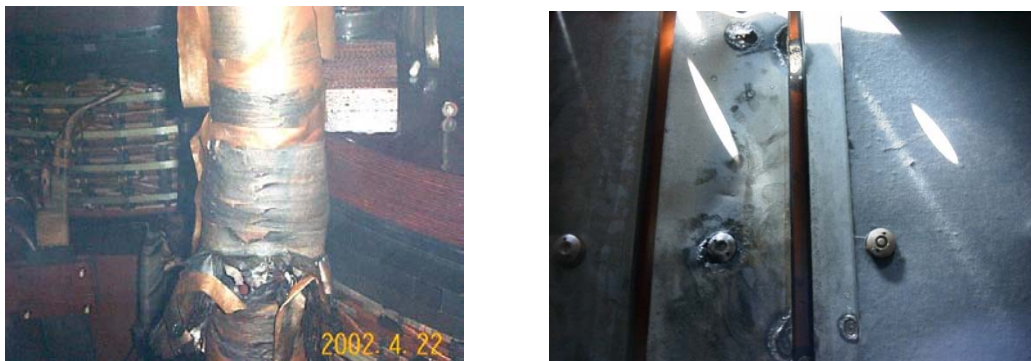
- An arc developed between B phase high voltage coil lead wire and shield plate of outer casing of the transformer (cf. Figure 0-9).
- The connection between terminal lug and lead wire outside bushing broke away (cf. Figure 0-9).

Figure 0-8: Photographs of the damaged lead wire and shield plate of outer casing of transformer

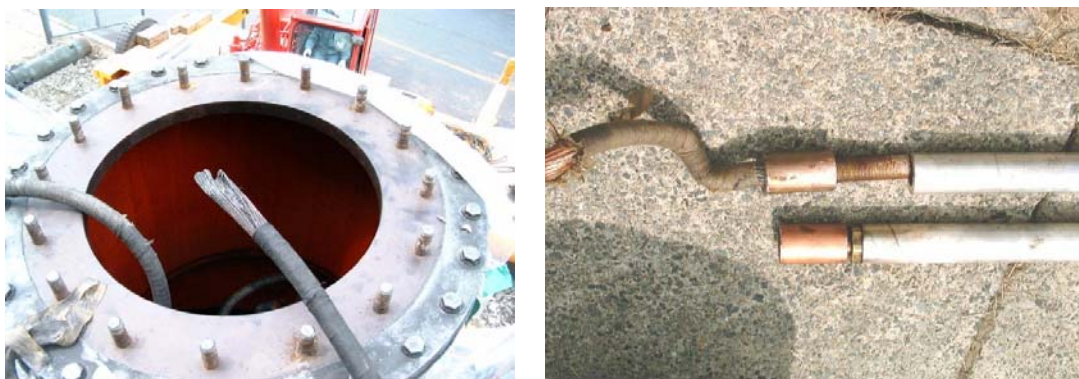
Figure 0-9: Photographs of the lead wire broken away from the terminal lug

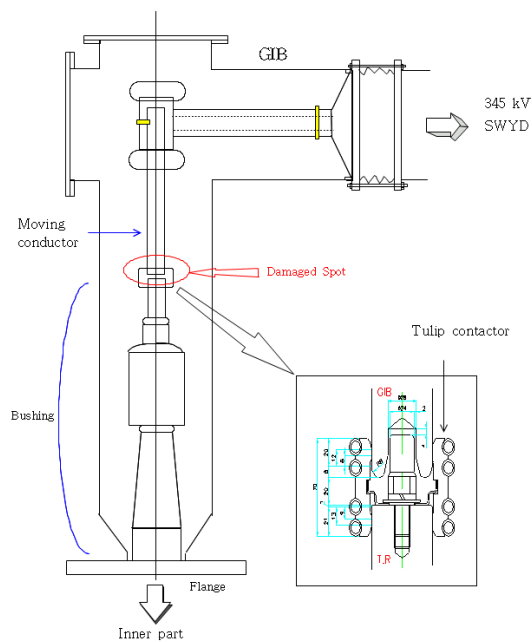
The root cause of the damage was a contact failure between the tulip contactor of the upper part of the bushing and moving contactor of gas insulated bus (GIB). A coupler between the bushing of the transformer phase 'B' and the GIB was overheated. The cracking hot gas was formed due to the insulation deterioration of the SF6 gas on the overheated spot, and a short circuit occurred between the conductor and the transformer case. The arcing induced melting of the tulip contactor of the bushing (cf. Figure 0-11).

Figure 0-10: Main transformer bushing failure part diagram

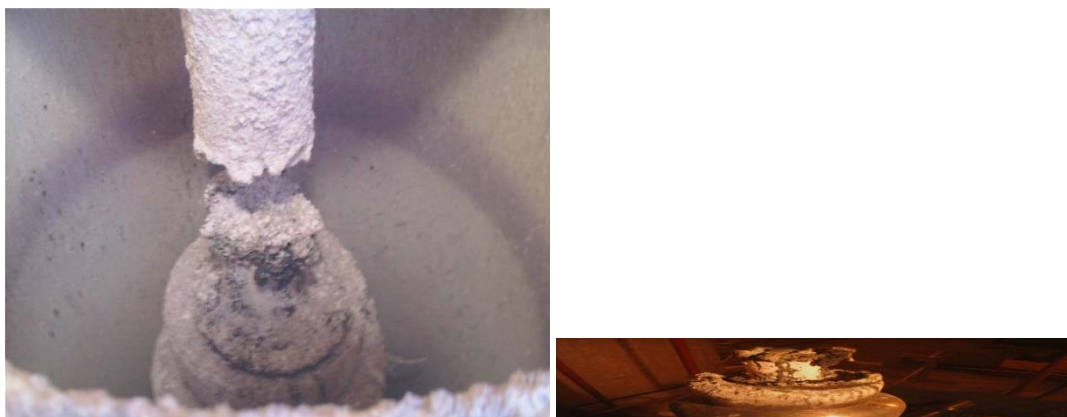
Figure 0-11: Photos of the bushing damage
