# PRESENT STATUS OF DEMO-NITE SiC/SiC CLADDING R&D

**Akira Kohyama**  
**NITE Corporation\***  
(OASIS, Muroran Institute of Technology)

# THE 2<sup>ND</sup> SCARLET SEGMENT IRRADIATION AT HALDEN

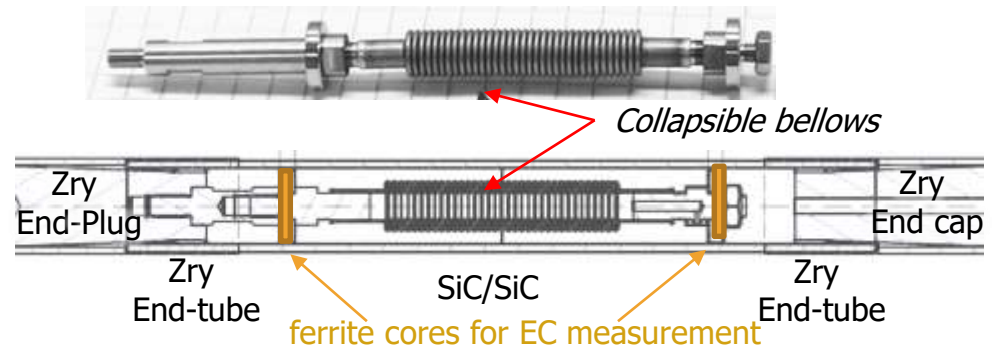
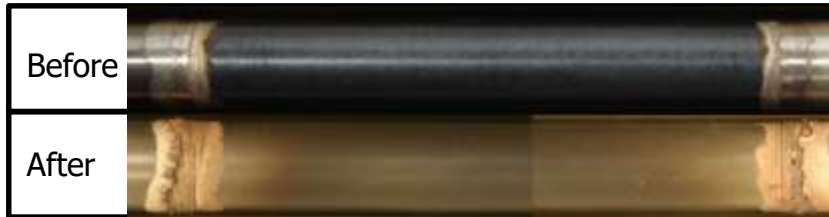
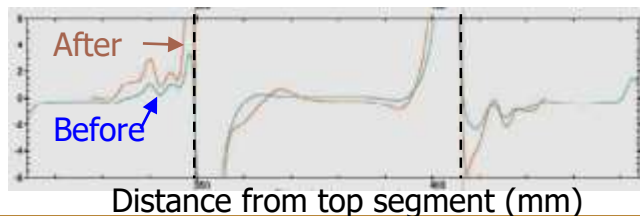
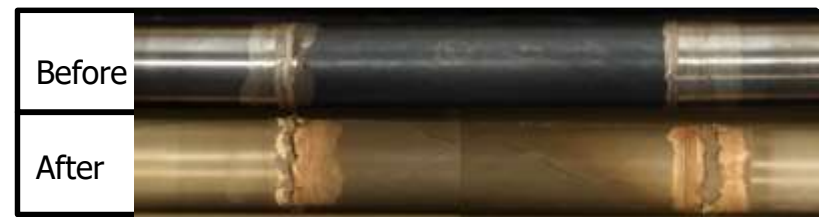
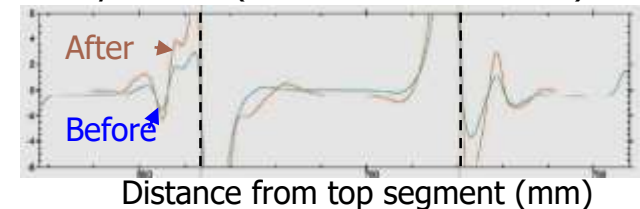
# DAMAGE EVALUATION BY EDDY CURRENT MEASUREMENT

Appearance of joined parts were significantly changed. But, significant damage in SiC/SiC tube couldn't be observed.

*Collapsible bellows are kept their locations after the test.*

→ **No failure during In-pile irradiation test**

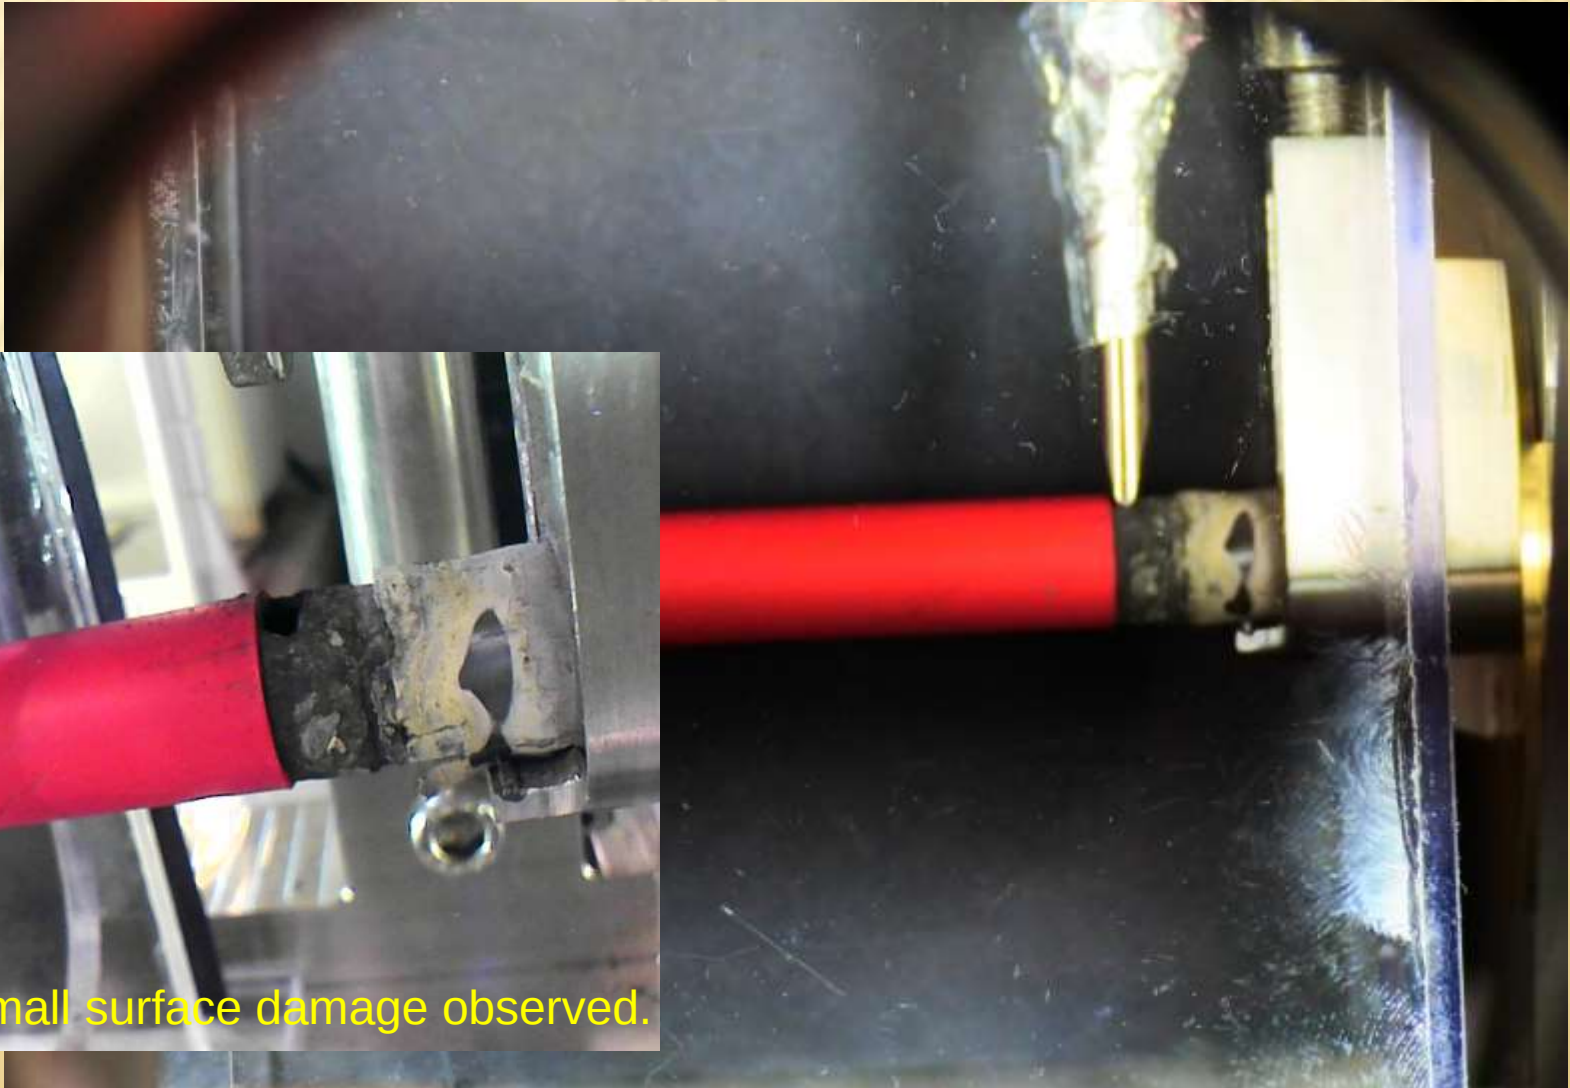
# HIGH SPEED CAMERA IMAGE OF THE DROP TOWER TYPE TEST - 1A-2 -

Only a small surface damage observed.

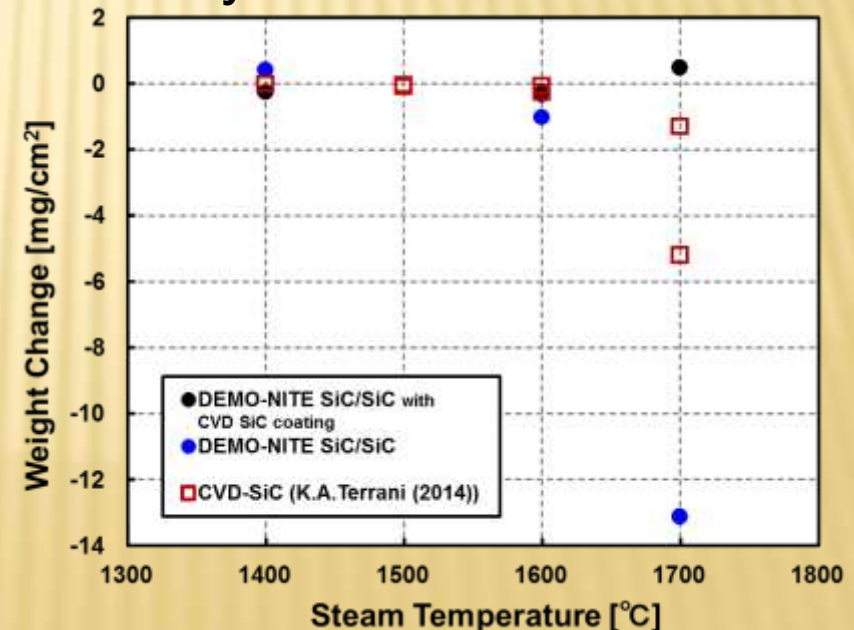
## ✕ Test Results

- + DEMO-NITE with SiC EBC presents excellent resistance.
- + DEMO-NITE without EBC presents large weight loss at 1700 C, but damage stayed only near surface.

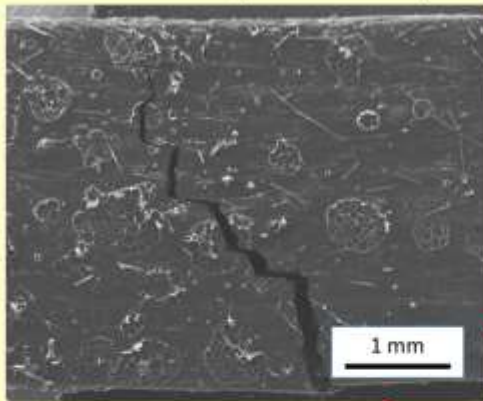
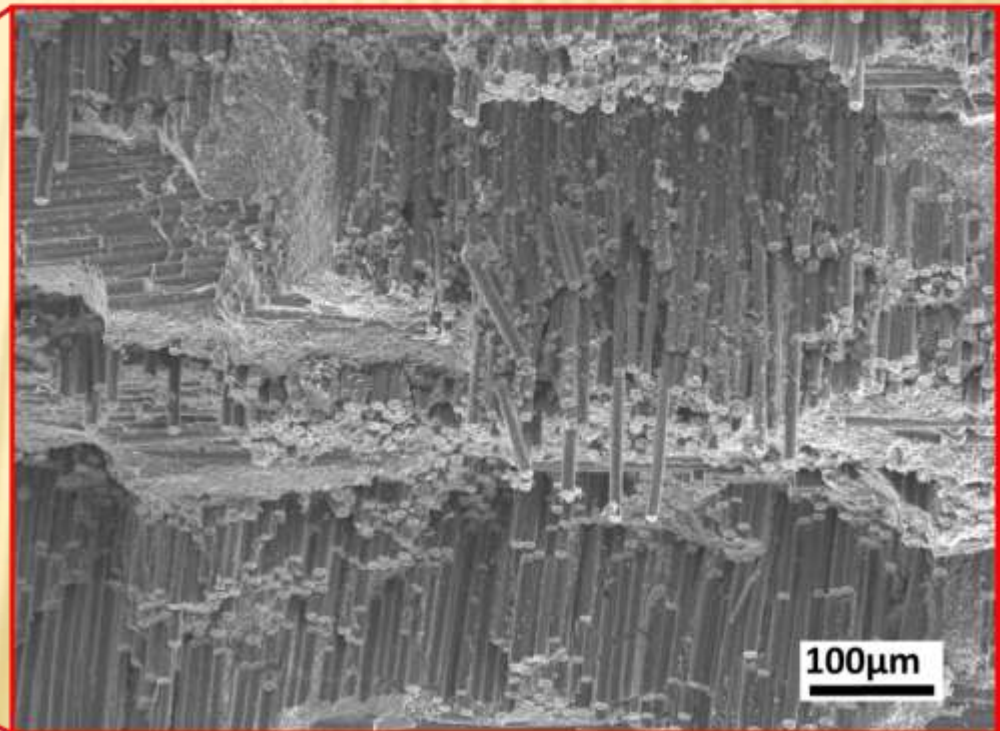
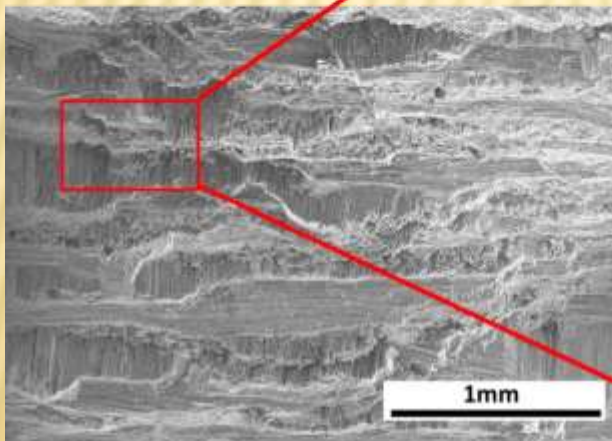
# FRACTURE SURFACE ANALYSIS RESULTS (3-2)

| Sample ID | Test Condition | Remarks |
|---|---|---|
| Muroran-SiC/SiC | 1350 C heating for 10min.followed by WQ for 50 cycles | After 50 cycles of WQT, no clear crack formation observed.<br>SiO <sub>2</sub> and/or Mullite bubbles and layers observed and loss of carbon interface and exfoliation of fiber bundles were observed. |

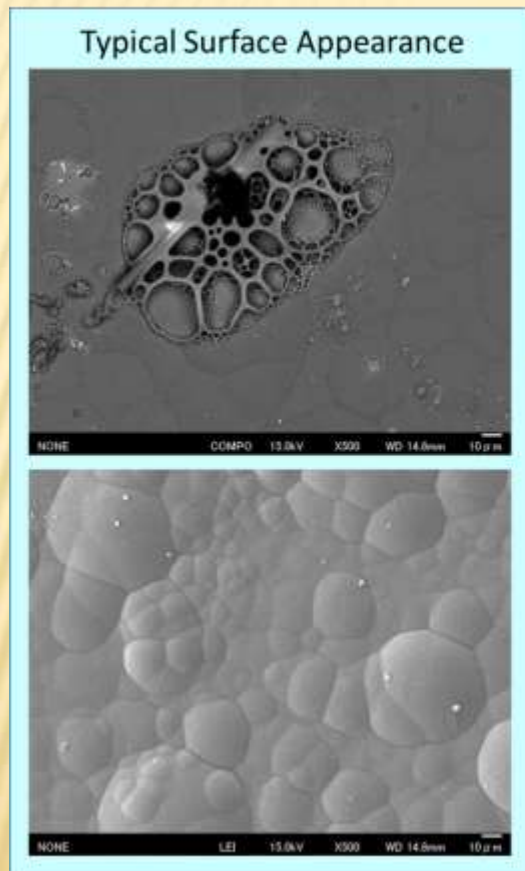
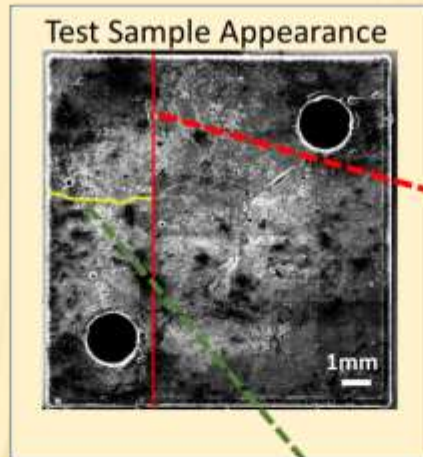
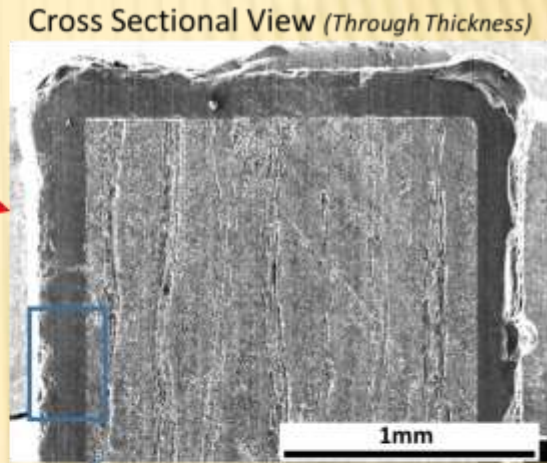
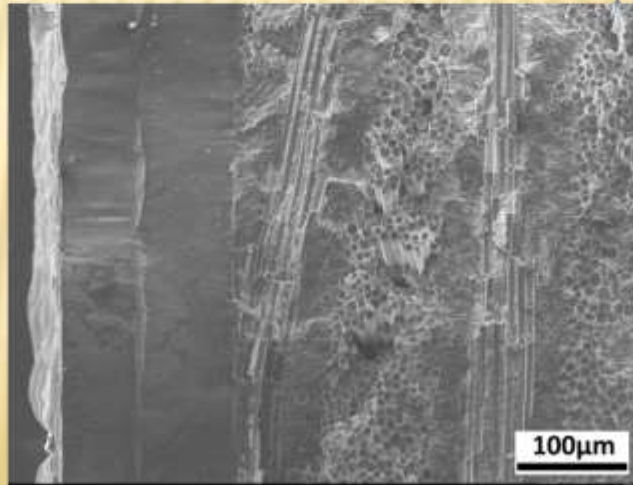
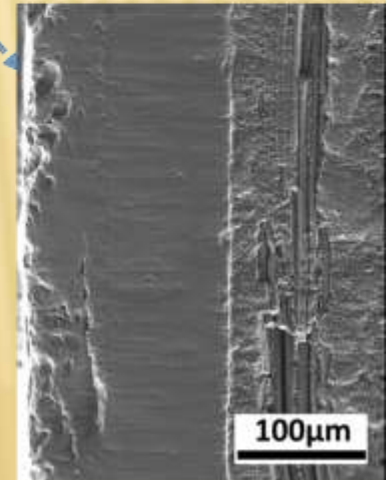
# FRACTURE SURFACE ANALYSIS RESULTS (4)

| Sample ID | Test Condition | Remarks |
|---|---|---|
| Muroran-SiC/SiC with EBC | 1350 C heating for 10min.followed by WQ for 10 cycles | After 10 cycles of WQT, no clear crack formation observed.<br>SiO <sub>2</sub> and/or Mullite bubbles and layers observed on CVD surface.<br>By the saw cutting of the sample, samples were broken. However, no exfoliation of CVD coating was observed. |
