# **Update on the Halden work on coatings**

## Performance of CrN coated claddings

### PIE results of the first in-core test on coated fuel rods

NEA- 5th EGATFL meeting, 12-14 April 2016 ,  
Boulogne-Billancourt, Paris

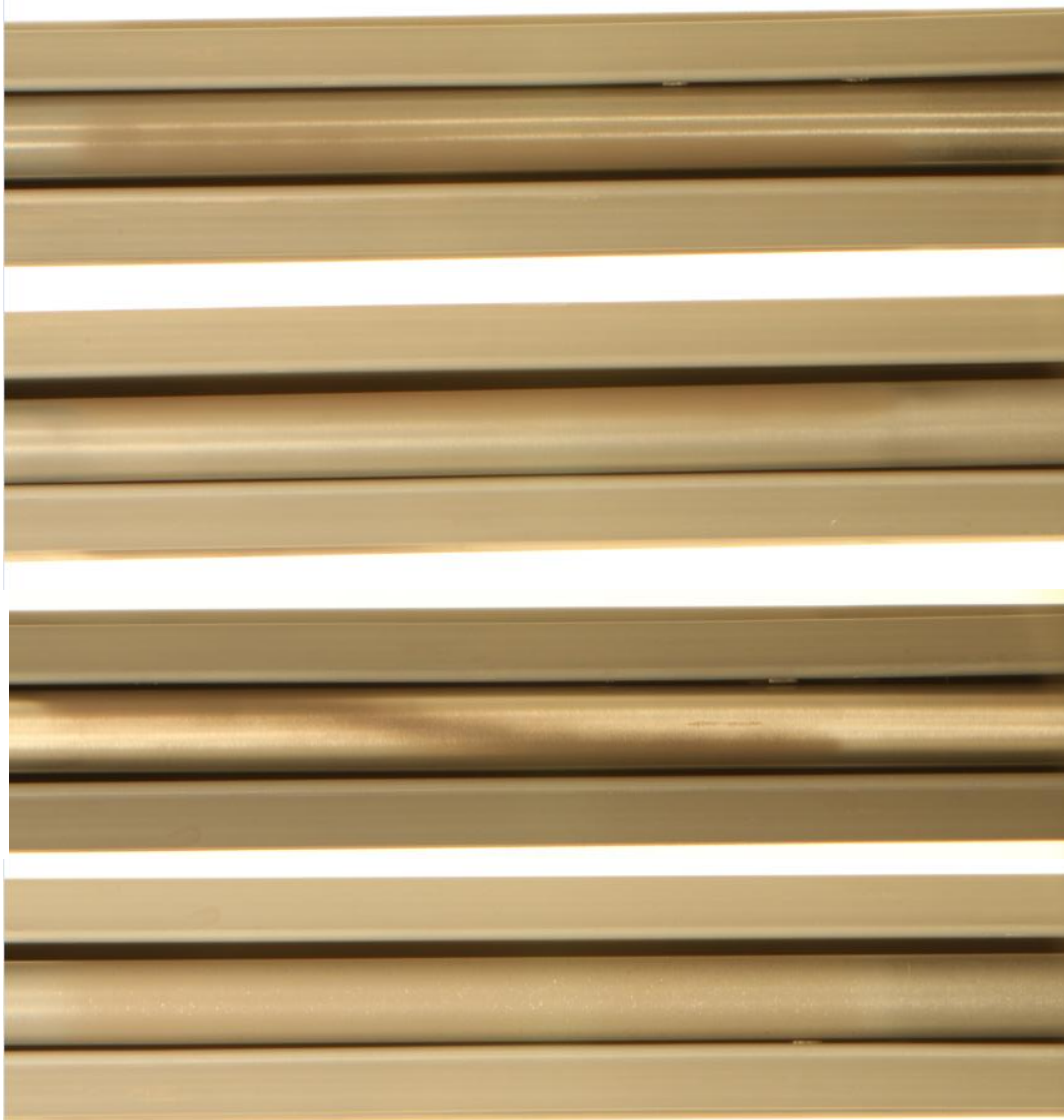
1. No coating

2. TiAlN

3. CrN

4. AlCrN

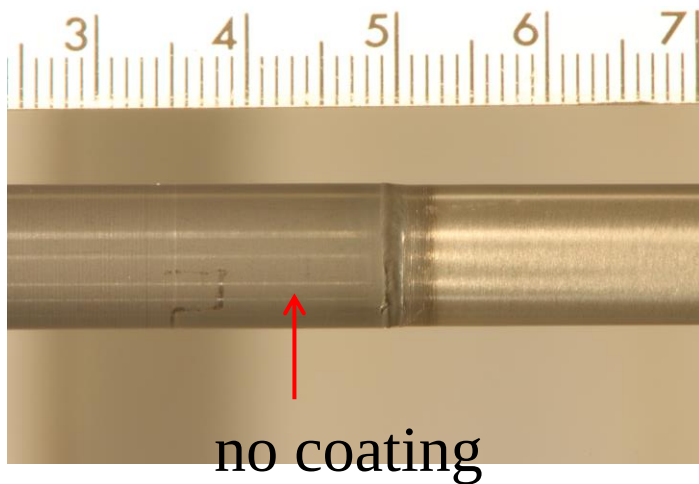
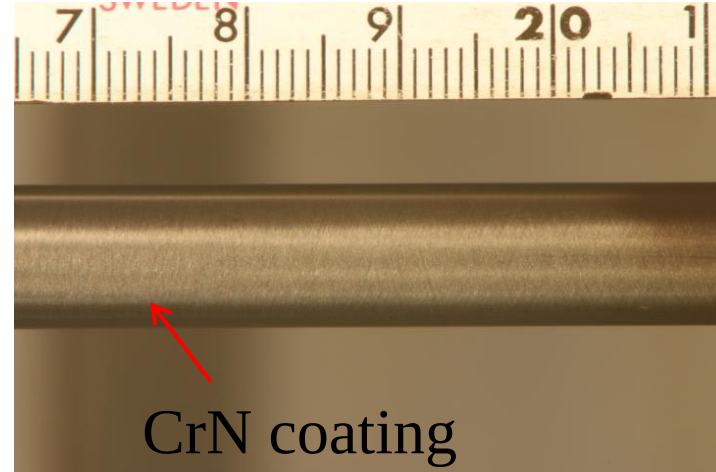
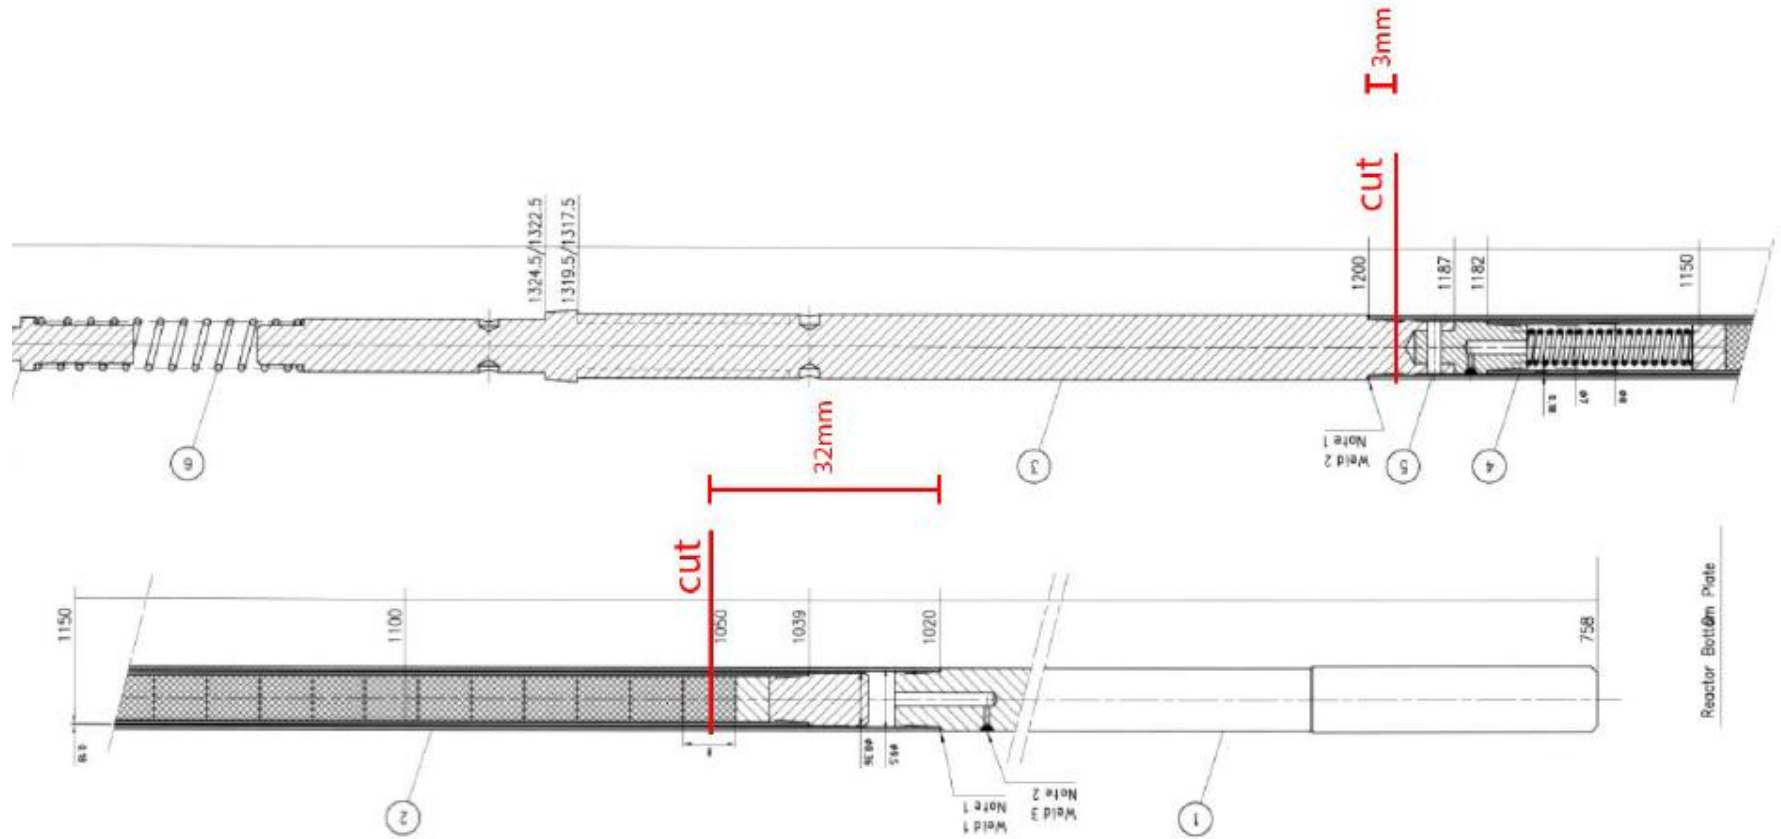
From visual inspection, the CrN seemed to survive

**Note:** Due to bending of downcomer tubes, the temperature of the rods increased substantially

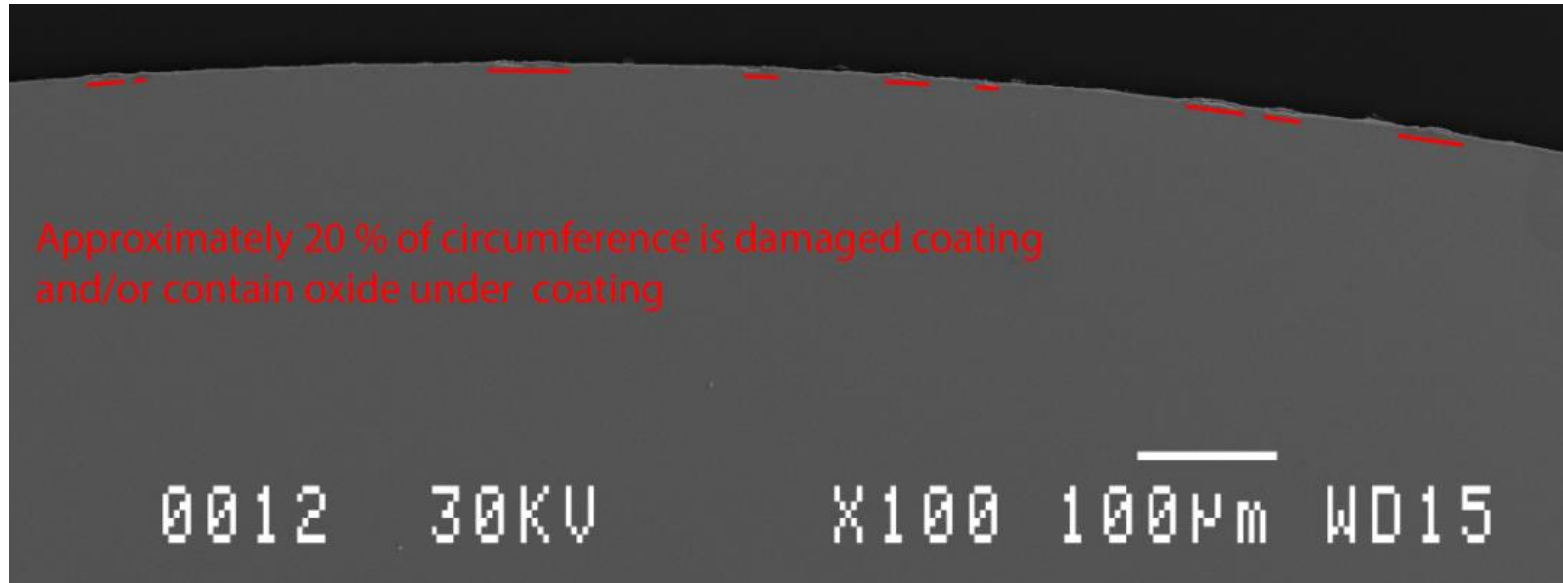
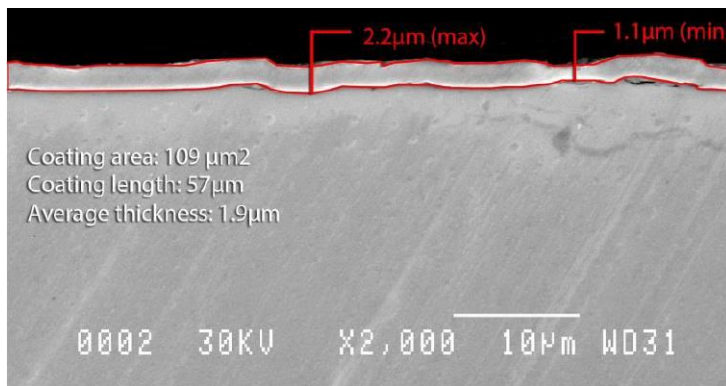
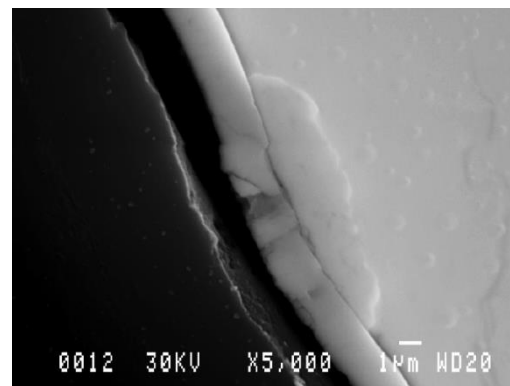
## SEM analysis performed on the CrN coated cladding

- TiAlN and AlCrN coatings disappeared
- CrN coating chemically stable (BRW and PWR)
- No reduction in coating thickness
- Despite «accident like» conditions, most of the coating still intact after 144 days
- When a crack occurs, oxide forms underneath and the expansion leads to further cracking
