OECD Fire Project – Topical Report No. 1

Analysis of High Energy Arcing
Fault (HEAF) Fire Events

NEA/CSNI/R(2013)6

**OECD FIRE Project - TOPICAL REPORT No. 1
Analysis of High Energy Arcing Fault (HEAF) Fire Events**

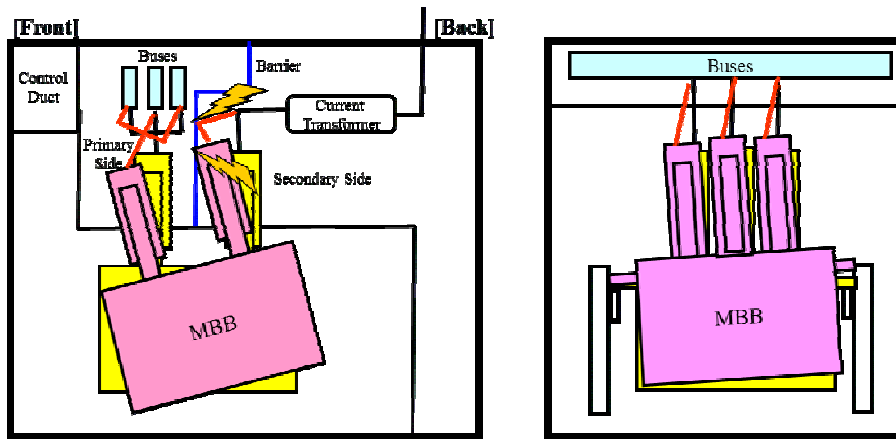
Figure 0-5: Simplified drawing for HEAF event in M/C 6-1A

The causes of arcing in the non-emergency M/C 6-1A may be the following (see Figure 0-5):

1. The earthquake shook Magne-Blast Breakers (MBBs), which were hung up by buses in the cabinet since MBBs were not fixed to the floor.
2. The shaking of MBBs resulted in damages of insulators and connectors. It resulted in short circuit and short to ground.
3. The short circuit and the short to ground of connectors resulted in arcing. The heat due to the arcing resulted in the fire inside the cabinet.

- To prevent seismically induced high energy arcing fault and fire, it was found that MBB being hung up in M/C was the essential cause of the event. Therefore
 - MBB shall be replaced by VCB, which is fixed on the floor of the cabinet.
 - A pedestal shall be inserted between MBB and the floor of the cabinet.
 These corrective actions are also useful to prevent failure of the startup transformer.
- To prevent an instantaneous trip of the emergency bus due to fire in the non-emergency MC;
- To prevent spurious current to emergency M/C from non-emergency M/C, the licensee will install a switch between these cabinets. Since the switch will be installed outside the non-emergency cabinet, arcing fault and/or fire will not affect functions of emergency components and/or systems. This corrective action is useful to prevent the event of spurious operation of the DG breaker.

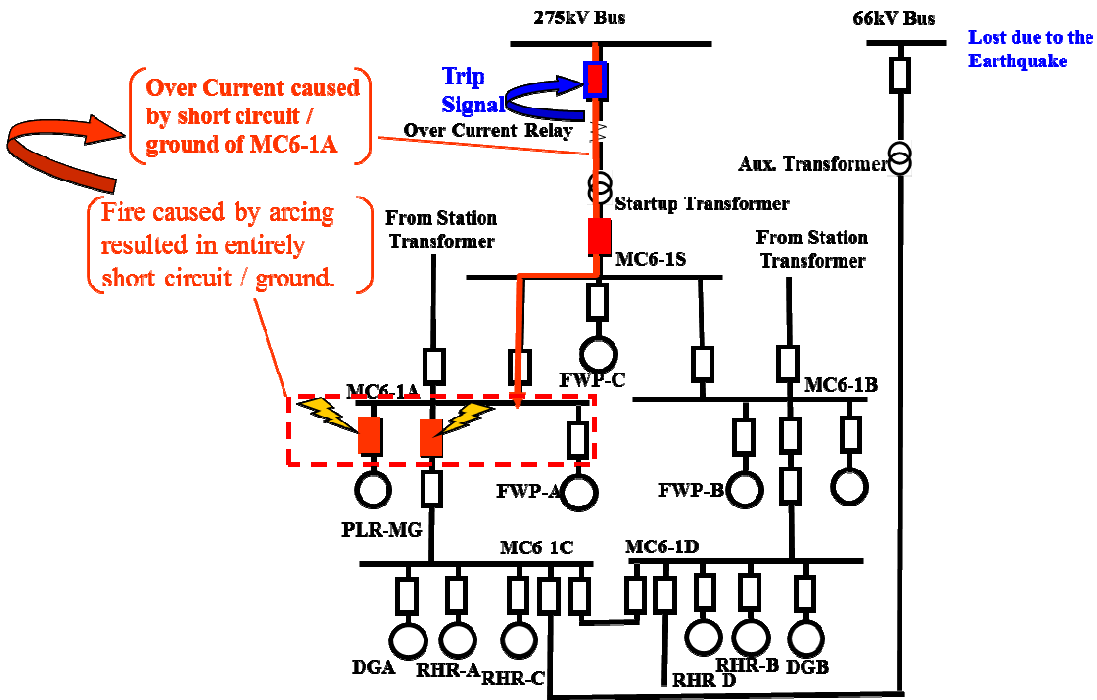
Figure 0-6: Simplified drawing for loss of offsite power by HEAF event

The fire in M/C 6-1A due to arcing caused a trip of the over-current relay at the upper stream of the startup transformer at 14:55 h. The trip of the over-current relay caused a loss of offsite power in combination with switching over of power supply system and loss of auxiliary transformer due to the earthquake (cf. Figure 0-6). The emergency buses were supplied by DG-A. After the loss of offsite power, decay heat was removed by SRV and RHR-A/C (suppression chamber cooling mode) being supplied by DG-A.

RHR-A/C were automatically isolated at 15:55 h due to instantaneous under-voltage of emergency bus C supplying to RHR-A/C. The instantaneous under-voltage of emergency bus C was caused by rush current from the emergency bus to auxiliary transformer damaged by the earthquake. The rush current was caused by a short circuit of synchronous detector in the non-emergency M/C 6-1A due to the fire. The short circuit caused spurious current from the non-emergency M/C 6-1A to emergency M/C 6-1C, inadvertently energizing the coil for the breaker from the emergency bus to the auxiliary transformer.
